# Sanitation Study

Evaluation of Dry Sanitation Systems in Namibia 2011

Authors: Cosenza, Ameli\*\*; Haxsen, Sören\*\*; Sattler, Yara\*\*;  
Wucherpennig, Kai\*\*

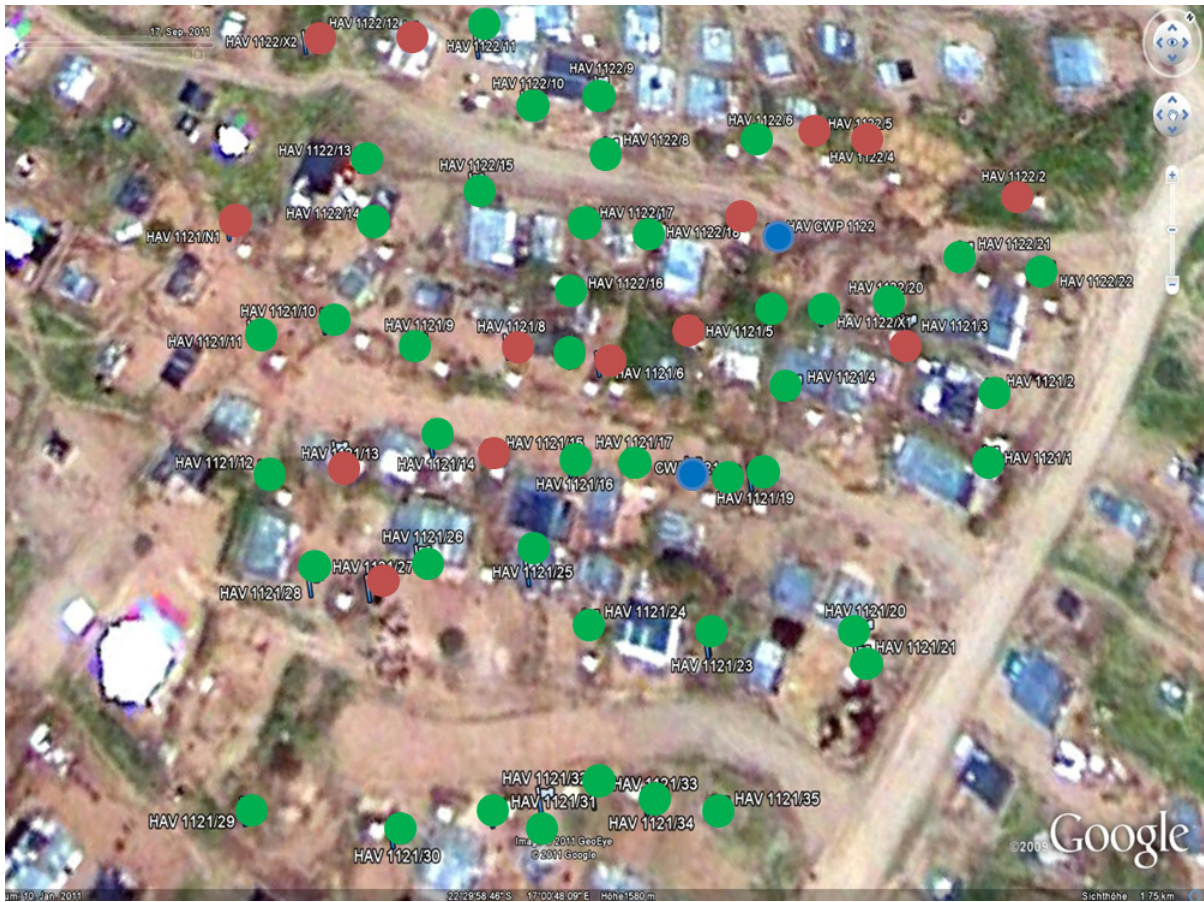
Picture 1: Otji-Toilets in Havana ext. 6

Out of these 58 existing Otji-Toilets, 44 facilities were observed and 43 beneficiaries were interviewed during the sanitation study. Picture 1 illustrates the project sight and gives an overview on the location of Otji-Toilets in Havana Extension 6.

At time of the survey 41 Otji-Toilets were actually in use. Interviewees stated that four Toilets were just temporarily not in use: two beneficiaries stopped to use the toilet because of filled up collection bins and two beneficiaries left their home on a temporary basis.

The number of toilets, which were generally not in use, was smaller than expected by the researchers: 13 Otji-Toilets were generally not used (four facilities were abandoned and four Otji-Toilets were still not allocated to a house and therefore locked by the authorities. And the reasons for the disuse of the remaining toilets are not known by the authors).

Legend: Green dots: evaluated Otji-Toilets (three of those are not in use); red dots: evaluation not accomplished (reasons differ and are described above); blue dots: water points; the GPS data for one toilet was not collected

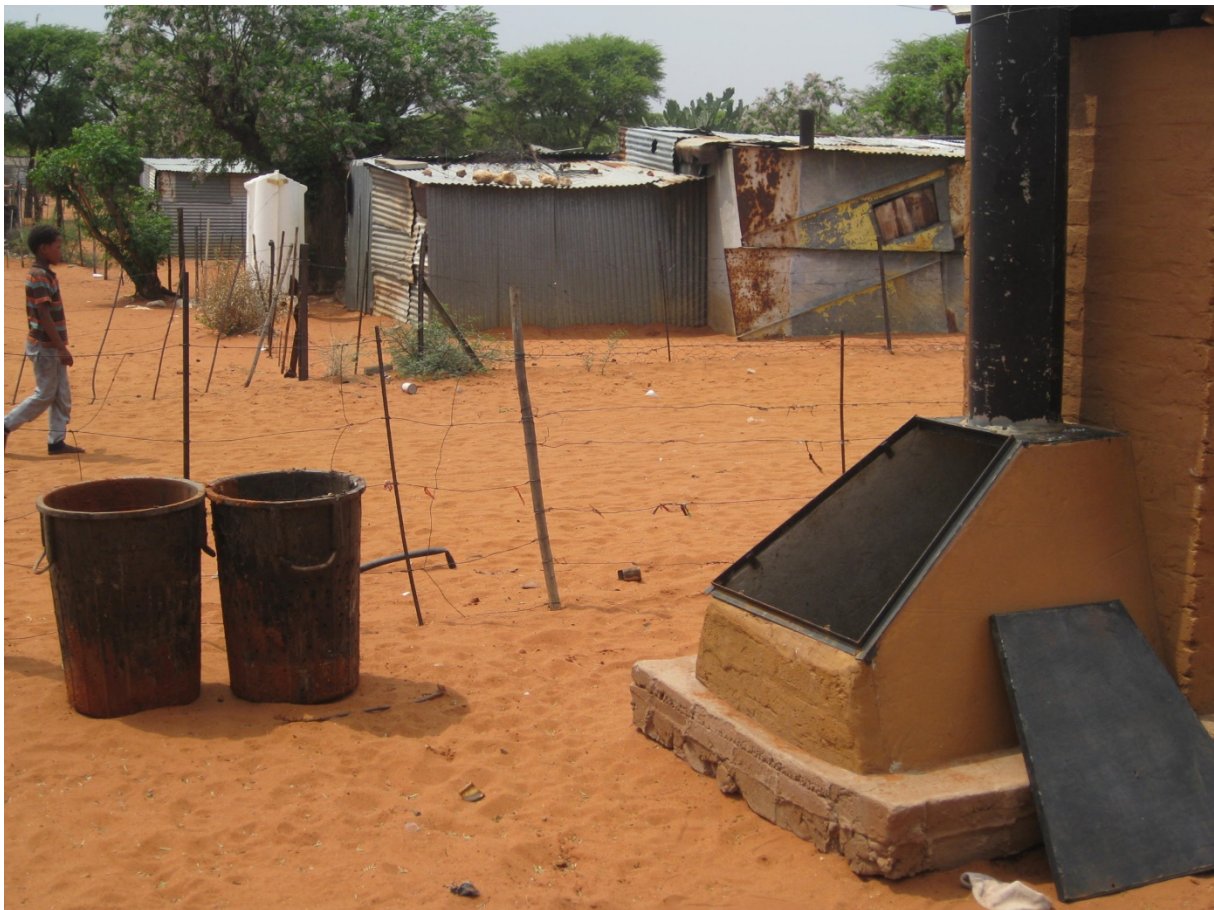
*Picture 5: Cleanout in Aranos*  
*Source: Picture taken by authors*

The construction of Otji-Toilets was hindered in some cases because of a very rocky and hard soil, so that a jackhammer was used. One interviewee reported about problems related to the natural conditions on operational level: urine in the collection bin should generally percolate into the ground through the wholes of the perforated bin, this does not happen in one case, as the ground under the bin is too rocky. As consequence liquids cannot drain off and produce smell.

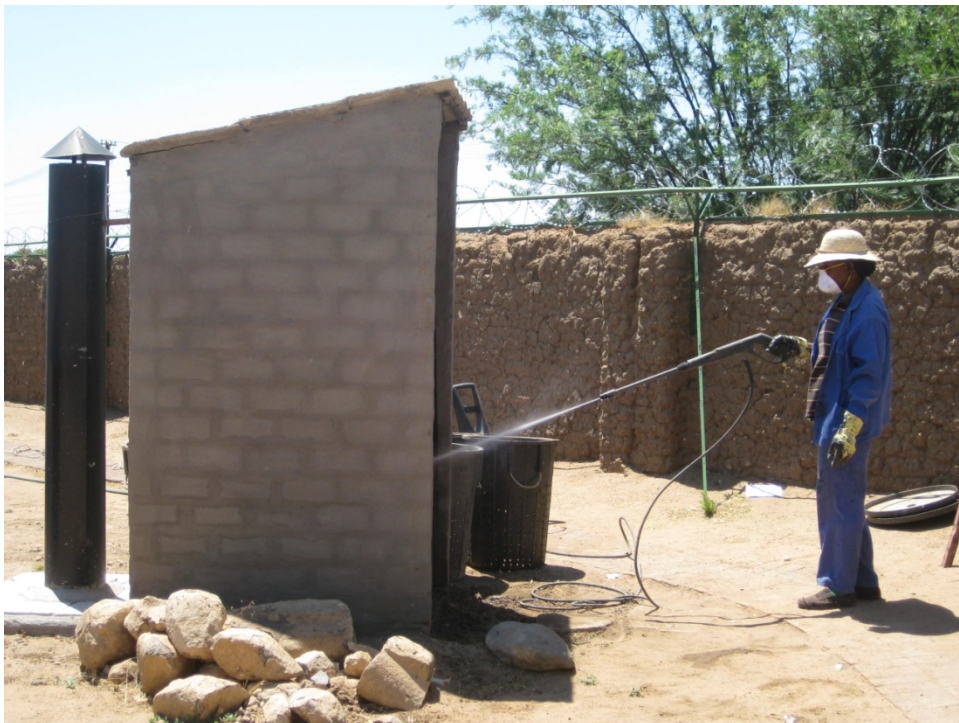
*Picture 6: Washing bins for reuse at CHP.*

Because of the increased utilization, the toilets have to be emptied more often in the future. In the beginning of the implementation of the Otji-Toilets in 2003, the bins were emptied only every sixth month. This trend shows that either the toilets are used by more household members or the toilet is used for other purposes, for instance as a dustbin. The collected waste is not reused as a fertilizer, but is dumped into a clarifier for drying. The emptied bins are cleaned by the external contractor and are reused.

*Emptied bins are cleaned in a construction for this purpose at CHP. Beneficiaries of Otji-Toilets in Otjiwarongo are provided with washed bins after the cleanout.*

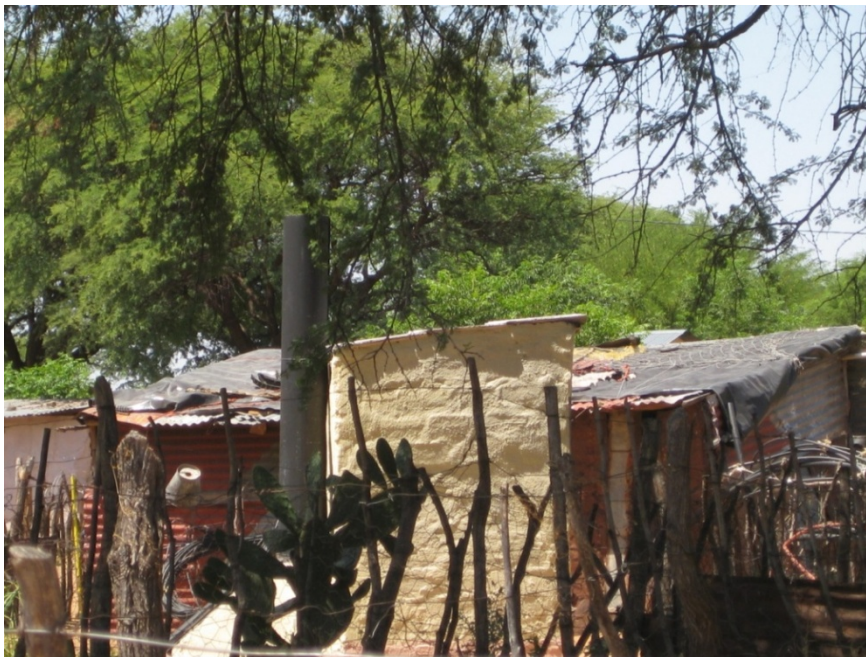
*Picture 7: Otji-Toilet in Drimiopsis*  
*Source: Picture taken by authors*

If people decide for themselves that they would like to have an Otji-Toilet, they contact DRFN in Drimiopsis, and the process for the implementation of the individual Otji-Toilet will be discussed. Users participate in the construction process by digging holes for the containment of the toilet. The financing of Otji-Toilets is organized in a different way than in other observed regions and seems to be very successful resulting in a deep feeling of ownership by beneficiaries. In Drimiopsis people invest in rates according to their financial capabilities. The toilet is locked until beneficiaries have paid the full amount of around 250 N\$. The facilities are subsidized by DRFN (Interview DRFN Drimiopsis 2011). To get a better impression for the entire results of the evaluation of dry sanitation systems in Namibia the next chapter will deal with the quantitative analysis of the gathered information from all regions where this project study took place.
